## ***Technology Demonstration Summary Sheet*** ***Starboldt™ Flashlamp Decontamination***

This demonstration tested Polygon Industry's Starboldt™ flashlamp technology for its ability to decontaminate approximately 600 square feet of concrete flooring by removing the coating layer without removing the concrete. The testing was performed on the service floor of the ANL - CP5 facility as part of the Large Scale Demonstration Program funded by DOE's Federal Energy Technology Center.

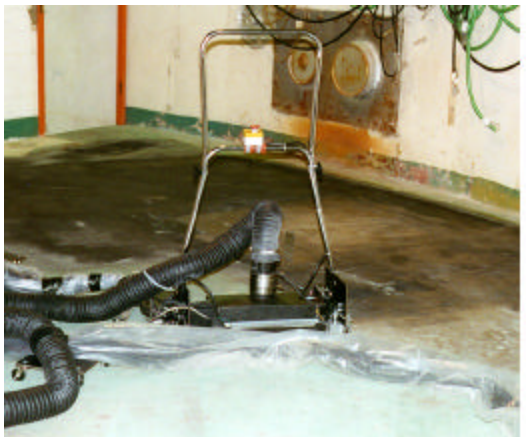
**Starboldt™ Flashlamp Head**

The Starboldt™ flashlamp system is a self-contained proprietary system for coatings removal and decontamination that uses xenon flashlamps to remove surface coatings from substrates. The system operates by pulsing an electric current at the rate of 4 to 7 Hertz (Hz) to a xenon gas-filled quartz lamp. With the aid of a reflector housing, the emitted light is concentrated and projected onto the surface coating. The coating absorbs the light energy, decomposes into a fine ash, and is removed from the surface by means of a debris scrubber and vacuum filter system attached to the head.

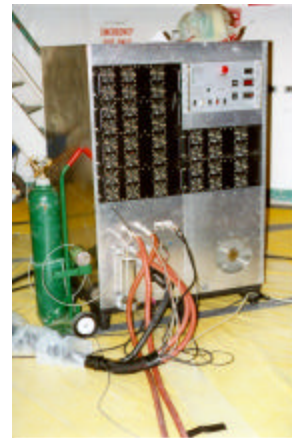
**Pulse Forming Network**
